Re: Final Report Approval  
Property  
Well 5 – June 3, 2008 Diesel Fuel Release  
Site # 706901, Primary Facility # 707295,  
Remediation Id #, 39259.  
Ex. 6 - Personal Privacy  
Springville Township, Susquehanna County

The Department of Environmental Protection (Department) has reviewed the Final Report, dated November 3, 2009, for the property located in the Springville Township, Susquehanna County. The report was submitted by URS Corporation. The report was submitted in accordance with the Land Recycling and Environmental Remediation Standards Act (Act 2), and constitutes a "Final Report" as defined in Chapter 3, Section 303 of Act 2.

The report was submitted to address the release of approximately 800-gallons of diesel fuel that occurred as a result of a break in a hose that supplied diesel fuel to the drill rig and booster. The release occurred on June 3, 2008 which impacted soil at the property. The report was also submitted to document the remediation of soil to the residential Statewide health standard under Act 2.

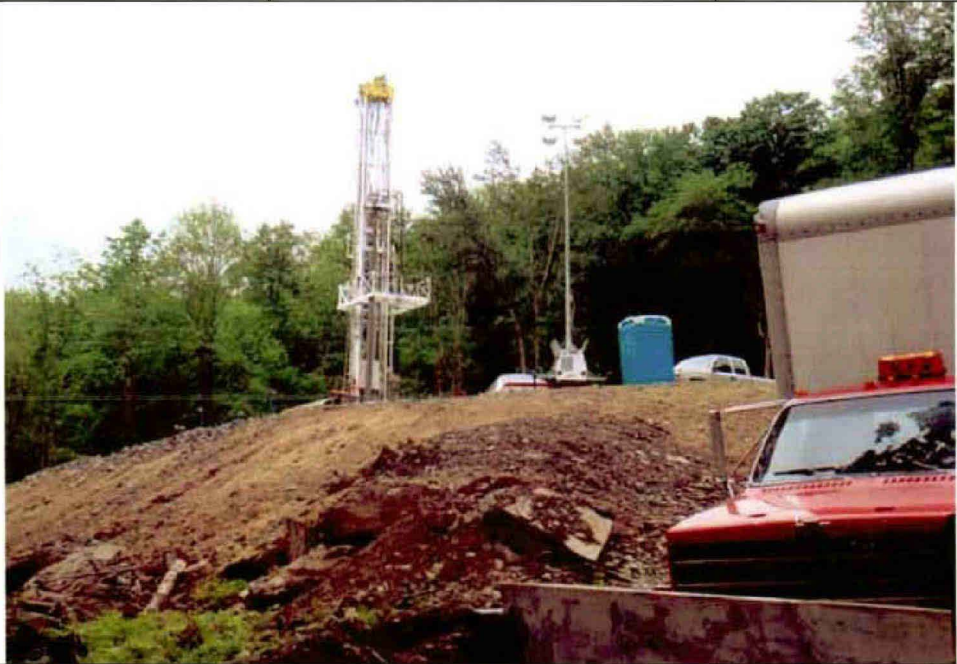
**Photo No.**  
2

Area of initial release  
from break in supply line.

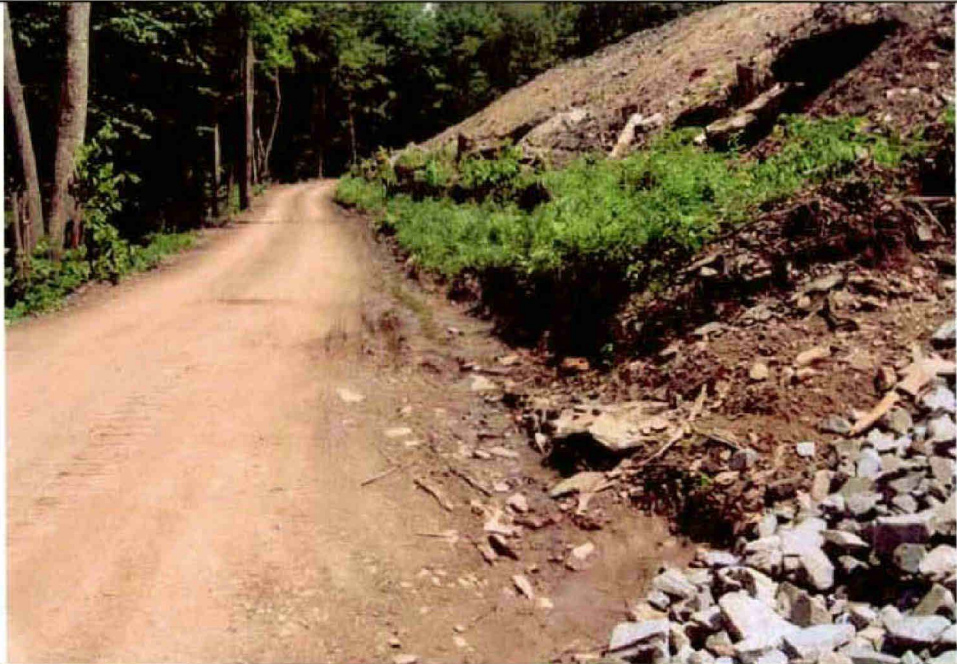
**Photo No.**

Inlet to culvert to underflow dam.

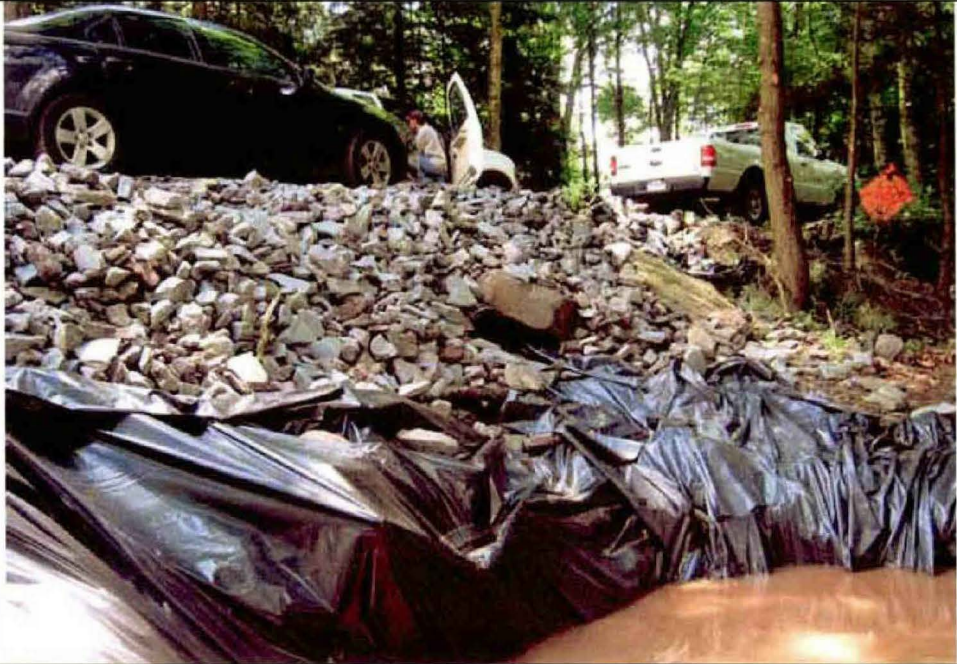
**Photo No.**  
6

Silt fence and straw bales preventing downhill migration. Location of Sample #9.

- Sample #8 – Active seep (sheen observed) near the drainage along Herb Button Road (surface);
- Sample #9 – sediment in drainage (about 5' below the level of the road, about 15' from the road) below the underflow dam containing water from culvert underneath Herb Button Road;
- Sample #10 – Sediment at the interface between surface water and the shoreline in the flooded area southwest of the release area.
- Surface water sample #1 (Cabot-01) – collected from near the west shore of the flooded area about 20 feet south of the release pathway entering the flooded area;
- Surface water sample #2 (Cabot-02) – collected from near the west shore of the flooded area about 100 feet south of the release pathway entering the flooded area;
- Surface water sample #3 (Cabot-03) – Collected from Meshoppen Creek about 4,000 feet downgradient of the release pathway entering the flooded area.

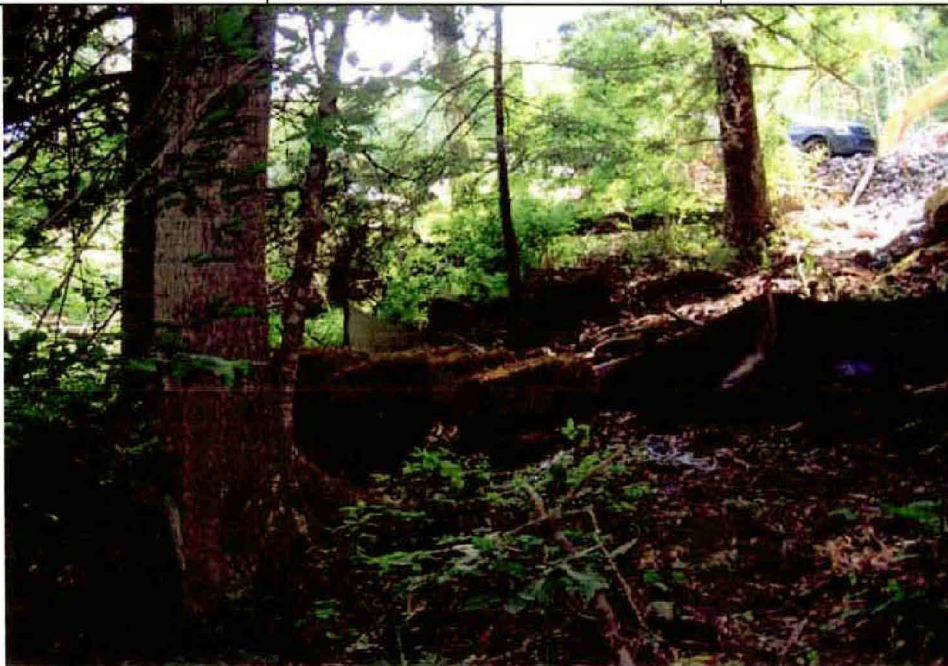
**Photo No.**

Flow entry into flooded depression area.

On June 3, 2008 at about 6:00 AM, the GasSearch Drilling Services Company (GDS) drilling crew found a fuel line leaking. At this time, GDS began the containment and cleanup process. Upon inspection, a break in the hose that supplied diesel fuel to the drill rig and booster was noted and a small area of diesel staining was observed in the riprap (**Appendix A – Photograph 2**). It was also noted that diesel was releasing from the pad at about the elevation of the geotextile, down the hillside (and into the ground surface), seeping from the hill side into a drainage ditch along Herb Button Road (**Appendix A – Photograph 3**), flowing into a culvert under the road (**Appendix A – Photographs 4, 5, and 6**), onto a hillside that drained to a flooded area created by a beaver dam (**Appendix A – Photographs 7 and 8**).

On June 3, 2008 at around daylight (6:00 AM) the GDS drilling crew found a fuel line leaking. Upon inspection, a break in a hose that supplied diesel fuel to the drill rig and booster was noted and a small area of diesel staining was observed in the riprap (**Appendix B – Photograph 2**). It was also noted that diesel was releasing from the pad at about the elevation of the geotextile, down the hillside (and into the ground surface), seeping from the hill side into a drainage ditch along Herb Button Road (**Appendix B – Photograph 3**), flowing into a culvert under the road (**Appendix B – Photographs 4, 5, and 6**), and onto a hillside that drained to the flooded area created by a beaver dam (**Appendix B – Photographs 7 and 8**). At this time, the cleanup and containment process began.

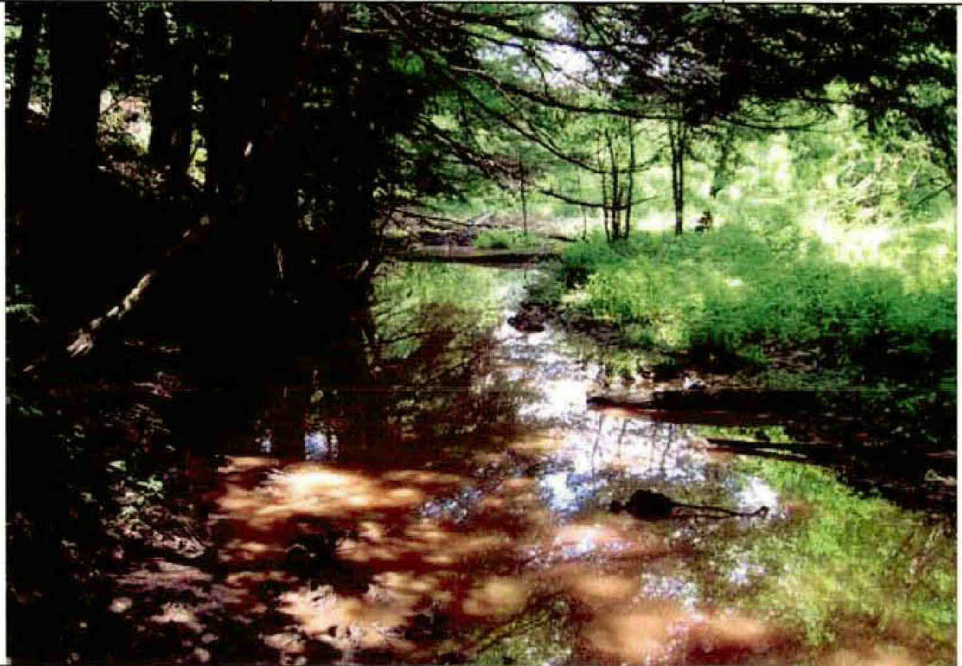
**Photo No.**  
**10**

Absorbent pads in diesel-impacted flooded depression.

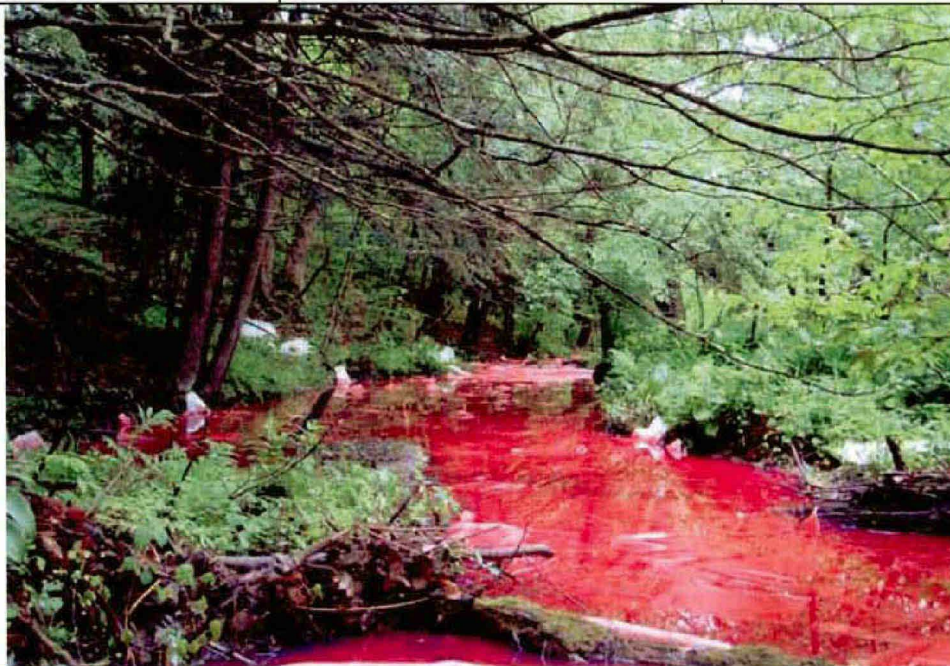
**Photo No.**

Absorbent pads and booms in diesel-impacted flooded depression.

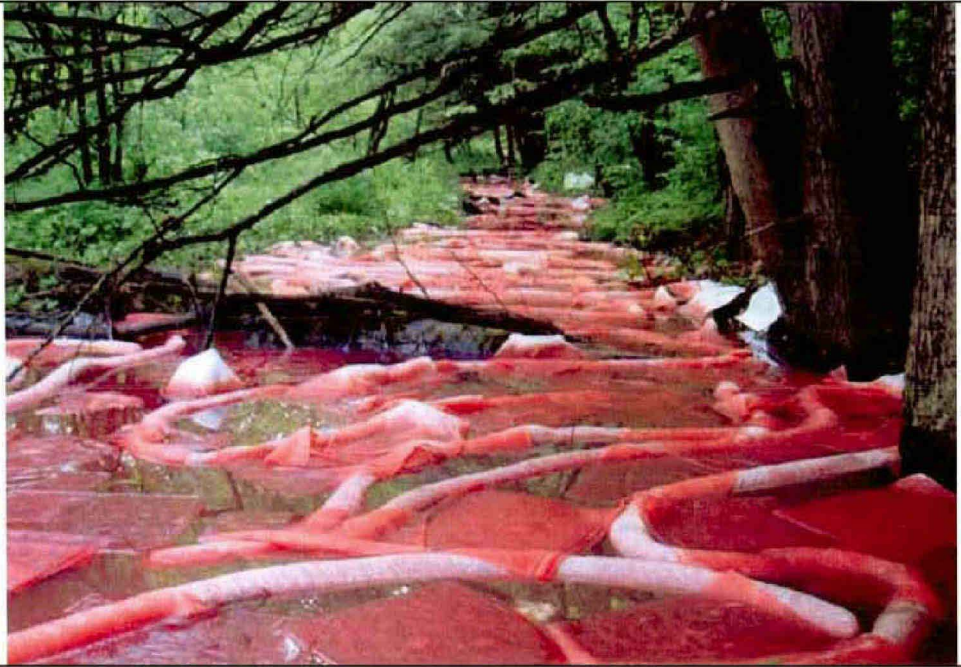
**Photo No.**

Absorbent pads and booms in diesel-impacted flooded depression.

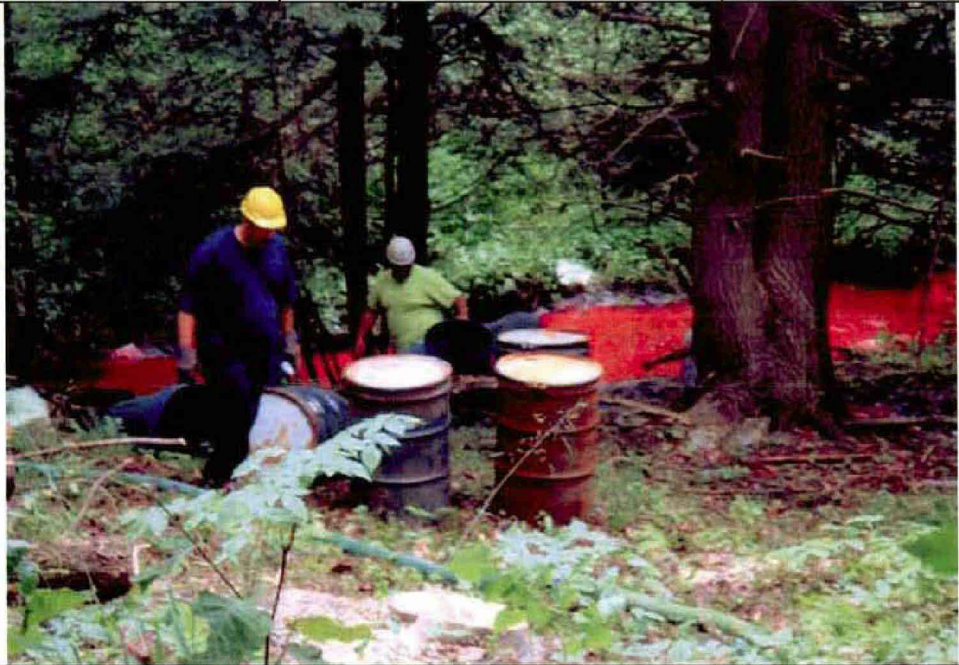
**Photo No.**

Diesel recovery via absorbent material from underflow dam (culvert under the road) on the hillside adjacent the road.

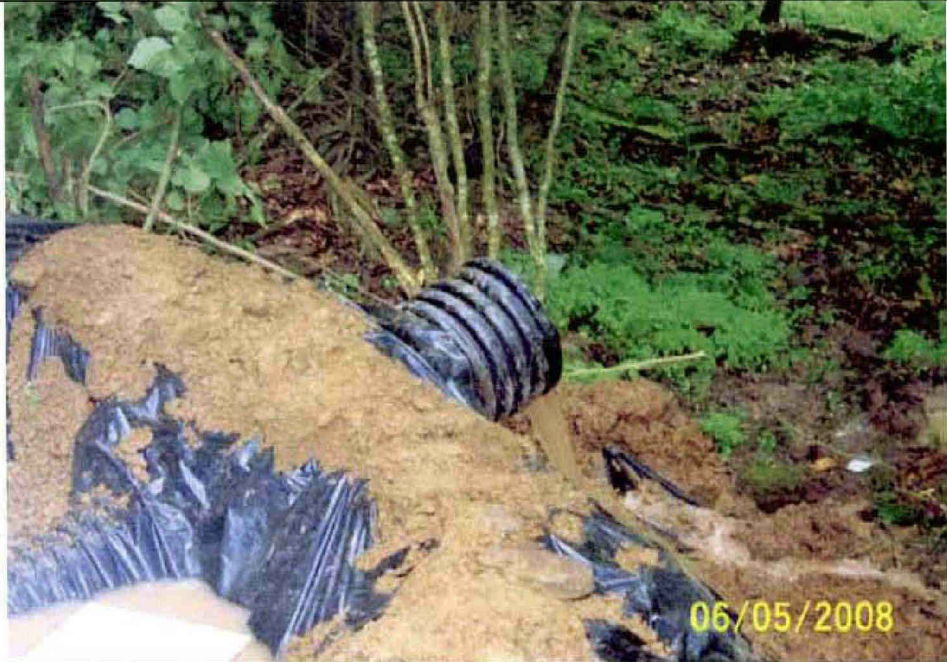
**Photo No.**  
18**Date:**  
6/05/08**Direction Photo Taken:**

**Description:**Sorbent material being  
used to recover diesel  
migrating from the  
drillpad to the culvert  
under the road.

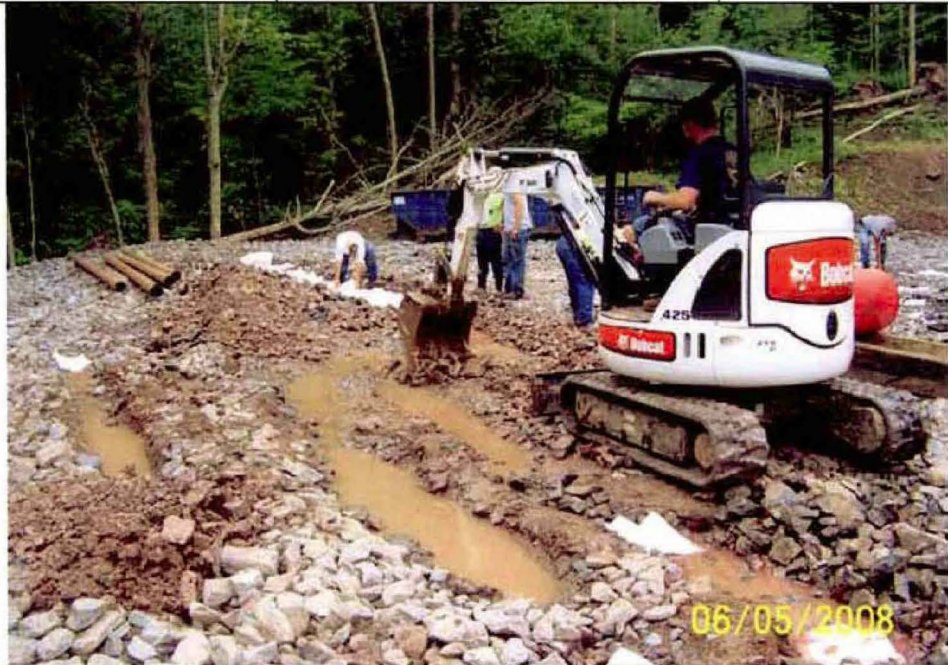
**Photo No.**

Excavation of recovery trenches in drill pad wellsite to recover diesel.

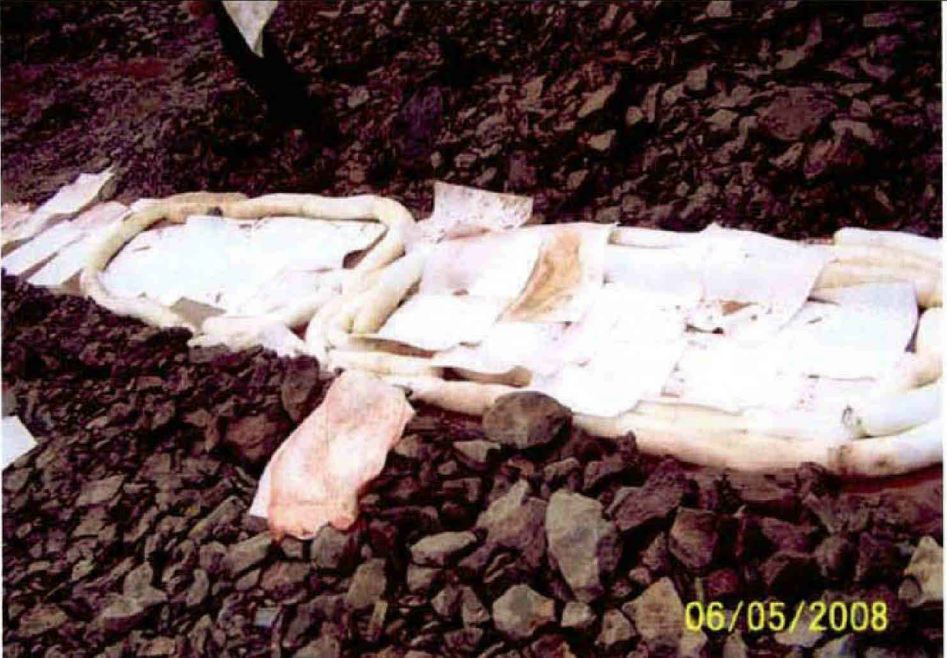
<b>Site Location:</b> Susquehanna County, Pennsylvania	<b>Project No.</b> 39938633
<b>Photo No.</b> 21	<b>Date:</b> 6/05/08

<b>Direction Photo Taken:</b> Northwest			
<b>Description:</b> Absorbent material in recovery trenches in drill pad wellsite to recover diesel.

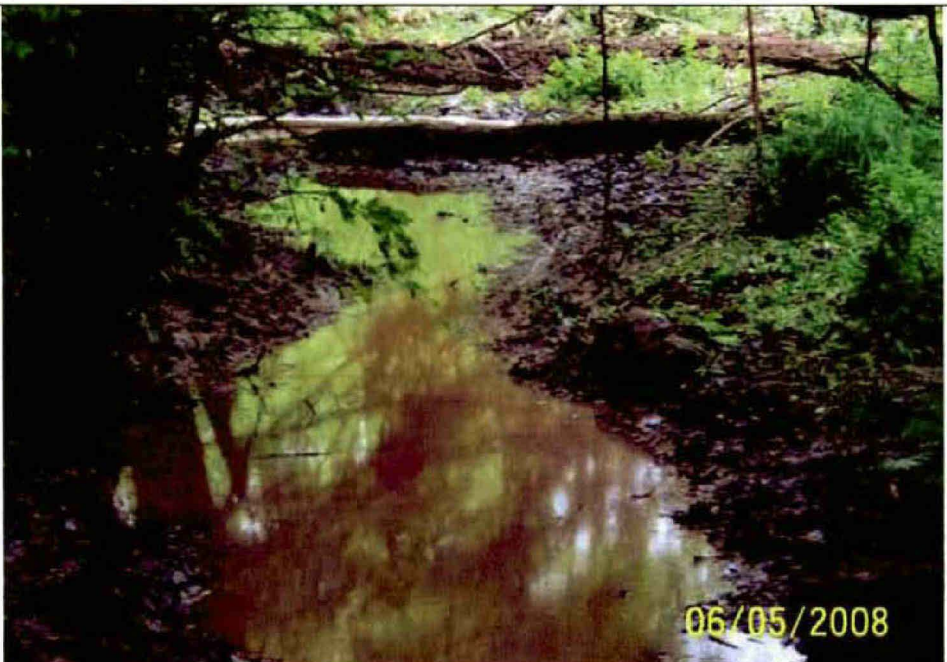
<b>Photo No.</b> 22	<b>Date:</b> 6/05/08

<b>Direction Photo Taken:</b> North		
<b>Description:</b> Earthen dam constructed on the north side of the flooded depression area that contained the spill and prevented migration of diesel downstream. Photograph is taken about two days after the spill occurred.

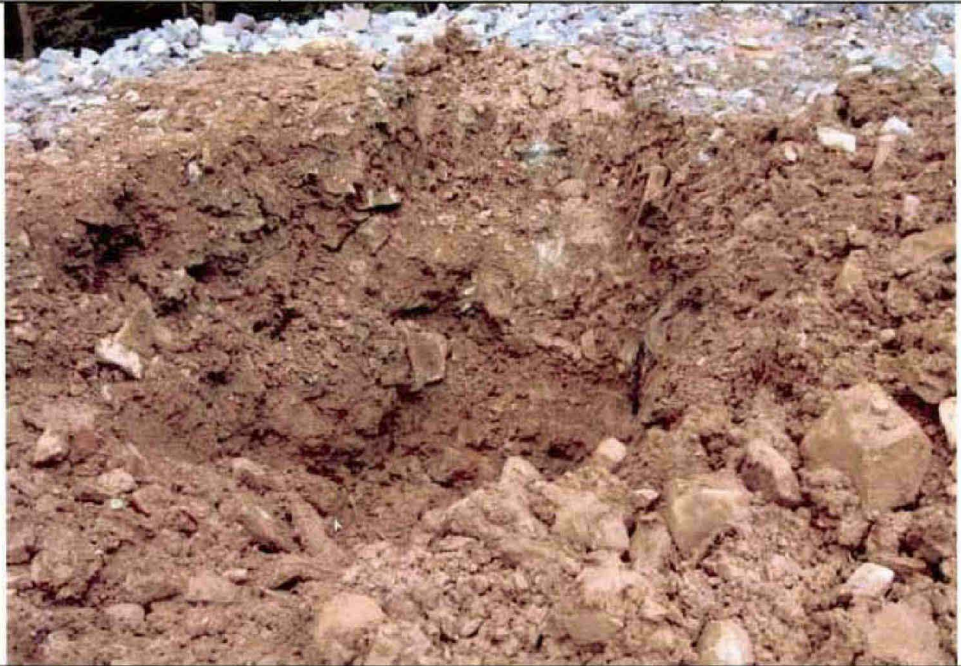
**Photo No.**

Test pit #4, sample #6 in drill pad area.

Test pits in the drillpad area indicated the upper 1 ft. of the pad was covered with riprap underlain by a geotextile fabric (**Appendix A** and **Photographs 24, 25, and 26**). At the time of the sampling activities, sediments above the geotextile were saturated to moist, while sediments below the geotextile were damp to moist. Surface samples along the pathway of migration of the diesel release and at seeps were typically collected from the upper portion of the area sampled, typically no deeper than 0-6" bgs.
